Plant Name: ****
Coordinator:****
File name: C:\AREVA\IKKP TEST\PUNP-B01
Date: 08/29/2008 15:56:30

Empath 2000 5.0 Analysis Results

PERFORMANCE SUMMARY

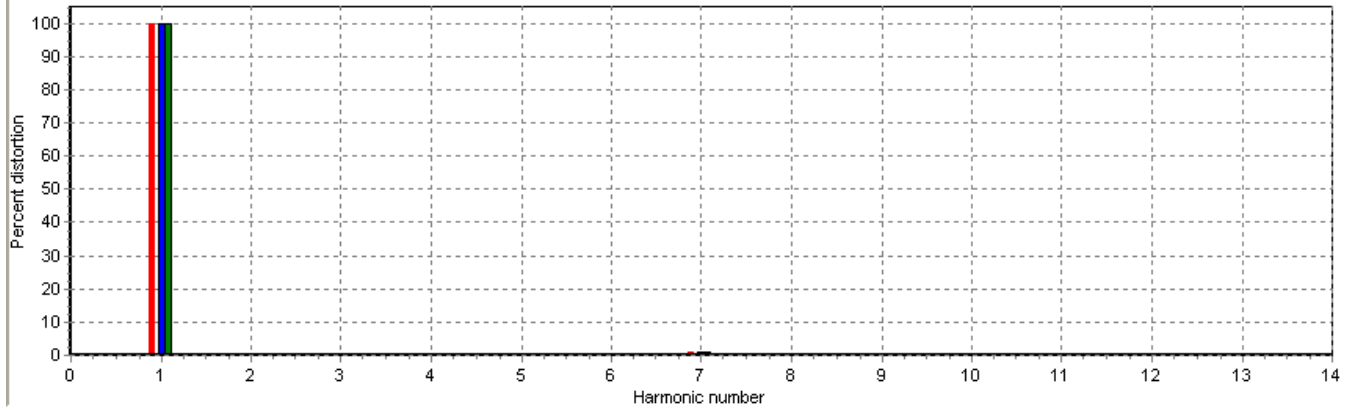
Figure- 1: Current Harmonic distortion graph

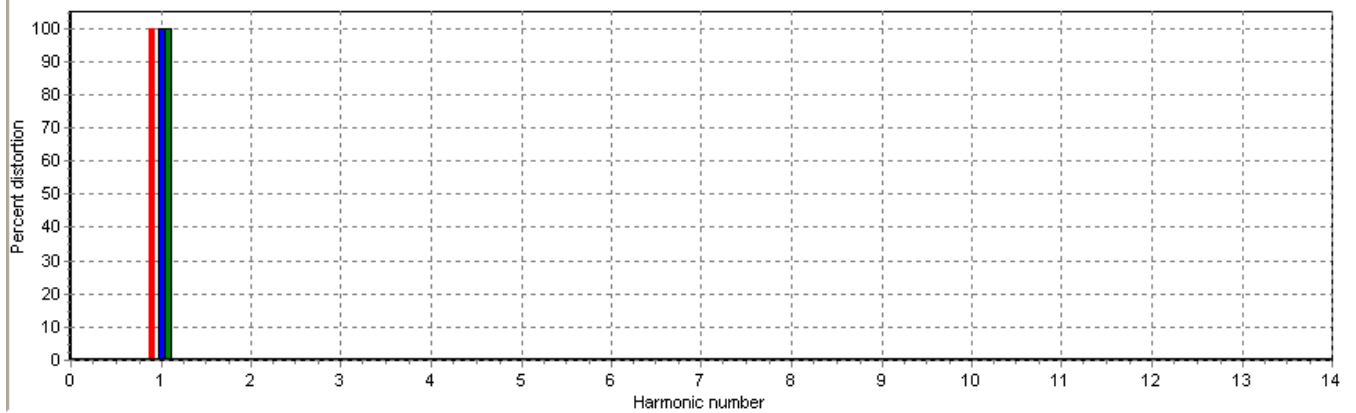
Figure- 2: Voltage Harmonic distortion graph

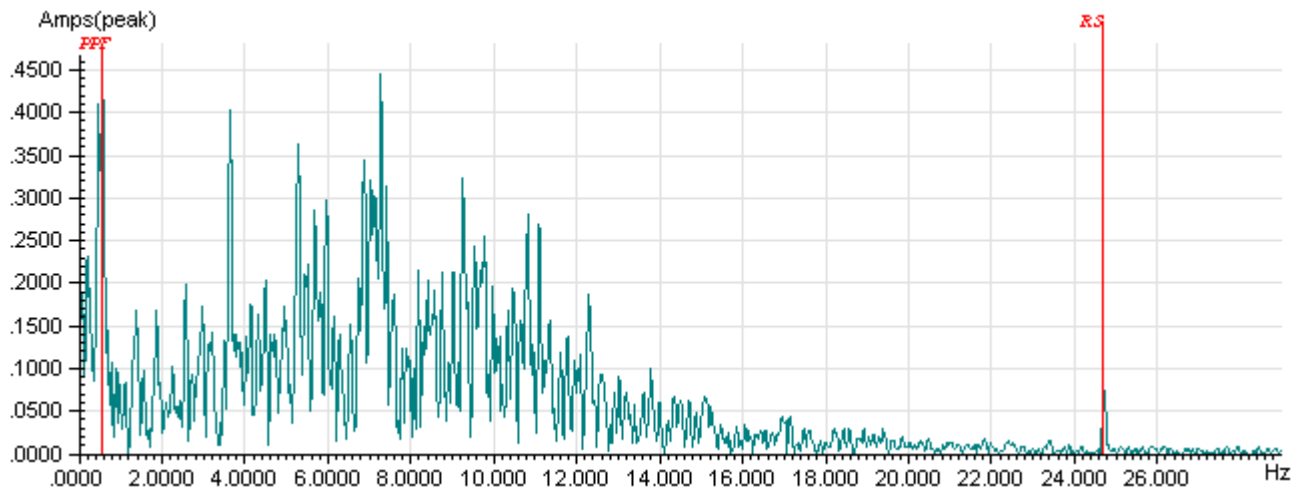
Summary of Rotor Bar Health				Power line dB diff.		Rotor bar Health index
	Se, fund	Se, harm	Level %	Upper SB	Lower SB	
Measured	0.550	3	0.5	-47.8	-45.4	1.6391
Severity level	Rotor Condition Assessment			Recommended Corrective Action		
6	Multiple cracked or broken rotor bars and end rings indicated. Also joint and ring problems			Overhaul ASAP

Figure-9 Ch-9 Current-1 { RMS } spectra-Demod
