Plant Name: ****
Coordinator:****
File name: C:\AREVA\IKKP TEST\PUNP-B01
Date: 08/29/2008 15:56:30

Empath 2000 5.0 Analysis Results

PERFORMANCE SUMMARY

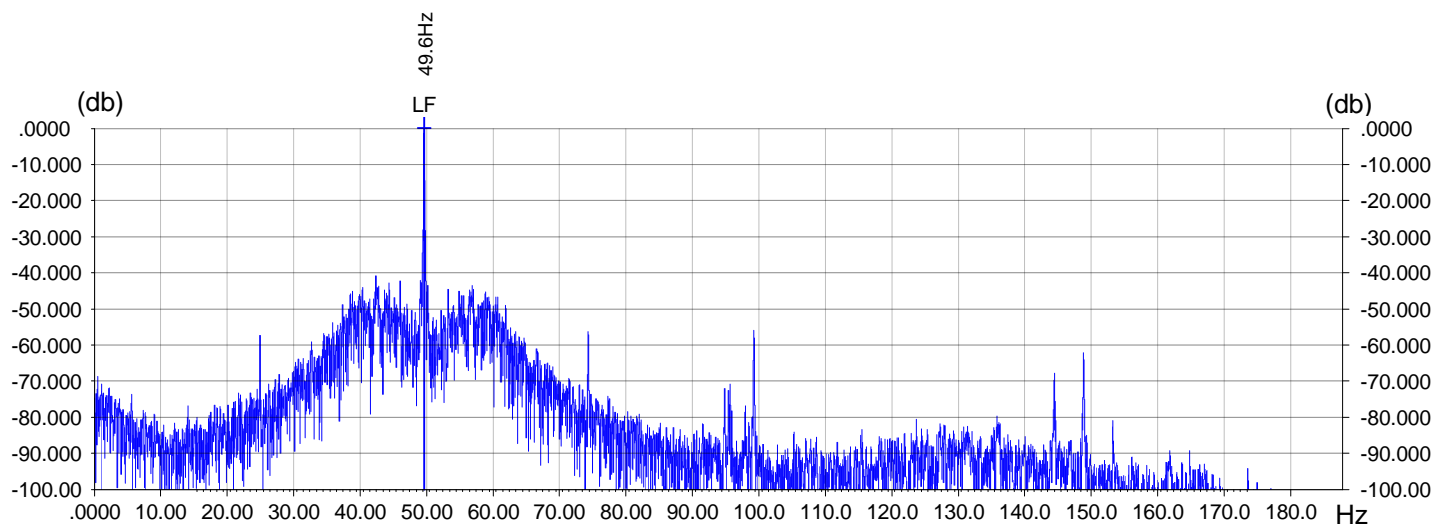
Ch-1 Current-1 spectra

Summary of Rotor Bar Health				Power line dB diff.		Rotor bar Health index
	Se, fund	Se, harm	Level %	Upper SB	Lower SB	
Measured	0.550	3	0.5	-47.8	-45.4	1.6391
Severity level	Rotor Condition Assessment			Recommended Corrective Action		
6	Multiple cracked or broken rotor bars and end rings indicated. Also joint and ring problems			Overhaul ASAP
